**Flood Control Project Maintenance
Levee Inspections**
LMA District Cover Sheet
Spring 2020 Levee Inspection Results

Reclamation District No. 0341 Sherman Island

Waterway			Bank	Unit Miles
Unit No. 01 Threemile Slough			Right	3.36
	Spring (March - May)	Summer (June - August)	(September - November) Fall	Winter (December - February)
Unit Maintenance Rating (Fall Only)				
Date of Inspection	3/25/2020 - 3/25/2020			
DWR Inspector	David Julian			
Accompanied By	Joel McElroy Reclamation District 341

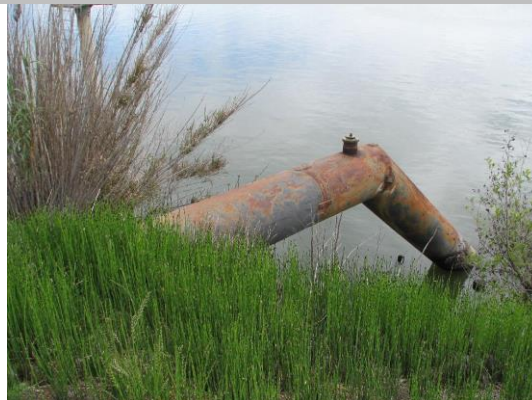
Photo 2 of 3 : UCIP_SP_2020_52252_37644.jpg

DS_ID:24215
FS_ID:52252
EP_NO: N/A
Repair Type: Non-Urgent
Crossing Status: Found
UCIP Comments: 05/05/2009 Dense vegetation limits the inspector's visibility to identify signs of pipe failure (leaks) along the slopes. Recommend removing vegetation along pipe alignment to conduct proper inspection of structure and appurtenances. (DWR UCIP - O. Magana)
FIELD_STRUCT_DESC: 30-inch steel drainage pipe through the levee, 11.1 feet below the crown. Corrugated metal cutoff wall around pipe at the center of the levee. Siphon breaker is located on both waterside (WS) and landside (LS). Pump is located on the LS approximately 300 feet from LS toe. Pipe is exposed on both levee slopes. Rock revetment present along WS slope. Marine Station number 1 located on WS with an attached small solar panel on top. [Additional Reference(s): DWR Levee Log, 1992. USACE Sacramento O&M Manual Unit No. 101, February 1962, (HLM 0.0). LMA encroachment station (STA) reference based on Map of Evacuation Route, Reclamation District 341 Sherman Island by Wagner Bonsignore Consulting Civil Engineers, A Corporation dated July 2012, STA 175+00].

View of pipe and siphon breaker located on WS--dense vegetation on slope.

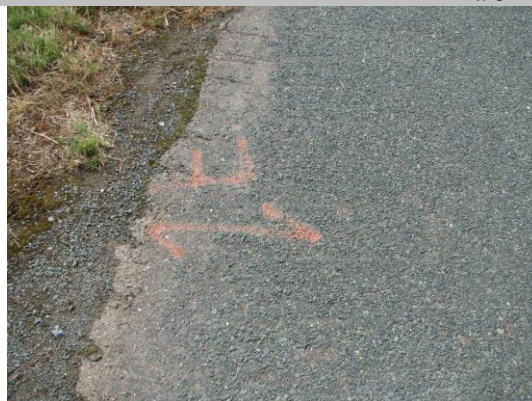
Photo 2 of 3 : UCIP_SP_2020_52253_37646.jpg

Underground Service Alert (USA) markings on road shoulder.

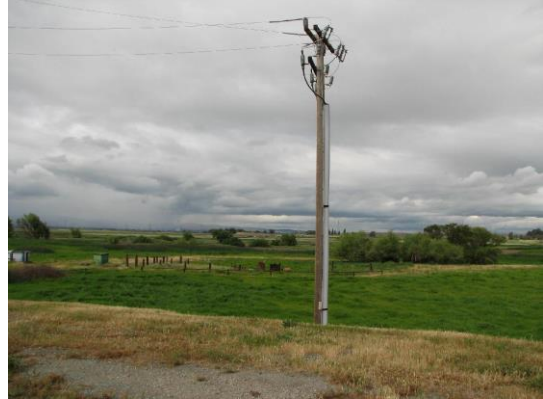
Photo 3 of 3 : UCIP_SP_2020_52253_37645.jpg

Power pole located on LS aligns with crossing.

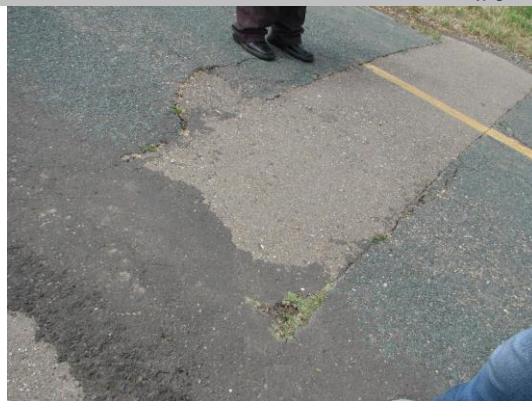
Photo 1 of 3 : UCIP_SP_2020_52254_37654.jpg

Cut along pipe alignment--unknown repair or maintenance date.

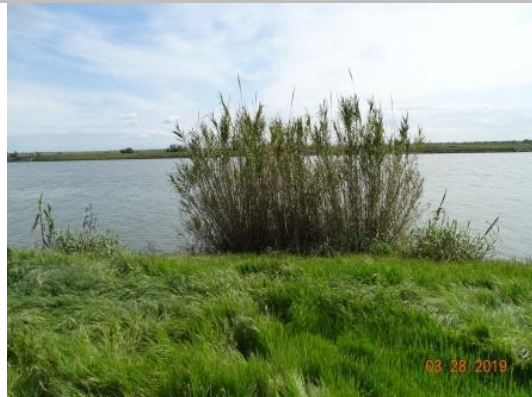
Photo 1 of 1 : SP_2020_RD0341_167_32_20200304_00006.jpg

View looking downslope at arundo on the waterside (Spring 2019).

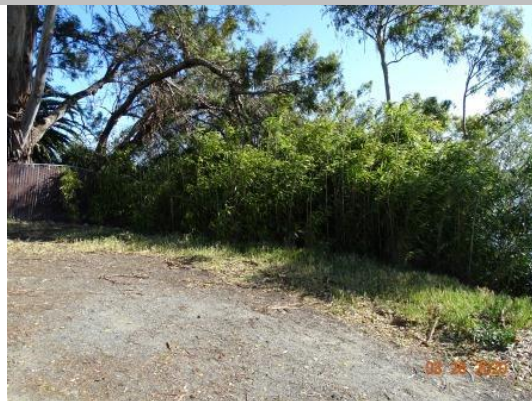
Photo 1 of 1 : SP_2020_RD0341_167_21_20200326_00055.jpg

View of thick landscaping vegetation on the waterside slope (Spring 2020).

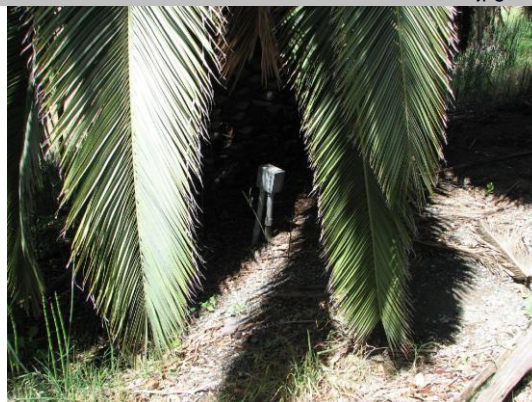
Photo 2 of 3 : UCIP_SP_2020_52258_37704.jpg

Power connection on WS no other appurtenances found.

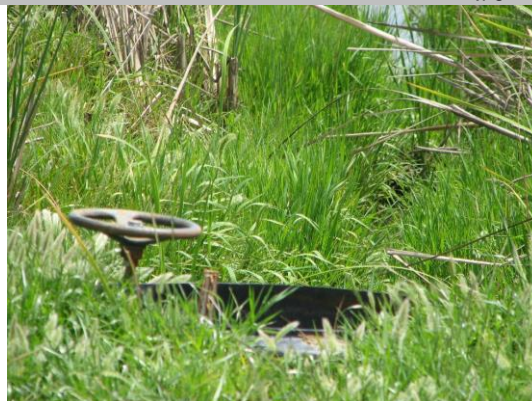
Photo 2 of 3 : UCIP_SP_2020_52264_37733.jpg

Riser and gate visible on LS--dense vegetation limits inspection.

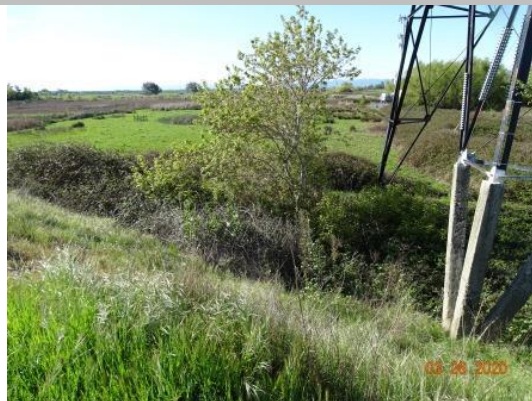
Photo 1 of 1 : SP_2020_RD0341_167_22_20200326_00054.jpg

View of thick blackberries at the landside toe (Spring 2020).

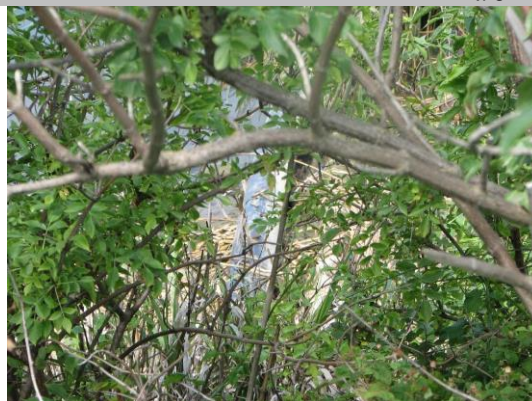
Photo 1 of 3 : UCIP_SP_2020_22203_37833.jpg

Limited access to waterward side--pipe visible through brush.

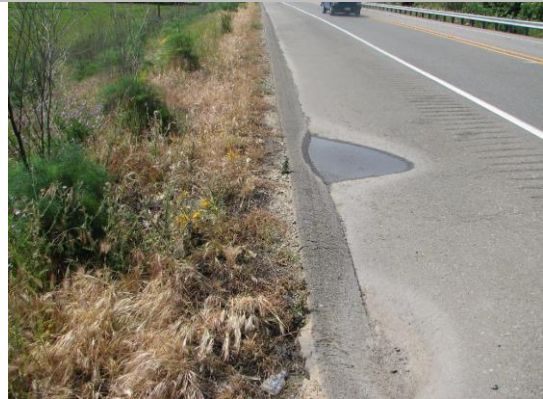
Photo 2 of 3 : UCIP_SP_2020_22203_37832.jpg

View of landward shoulder and low spots on highway.

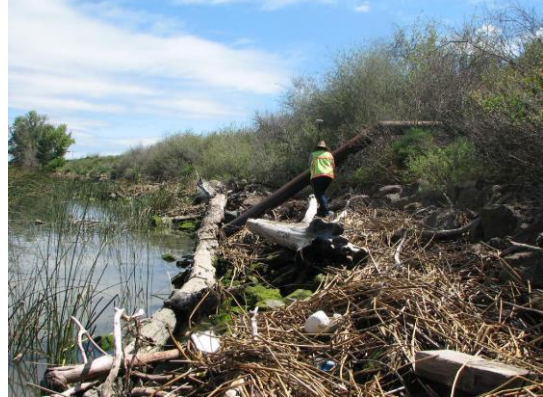
Photo 1 of 3 : UCIP_SP_2020_53343_37842.jpg

View of crossing on waterward side. Dense vegetation limits inspection of crossing.

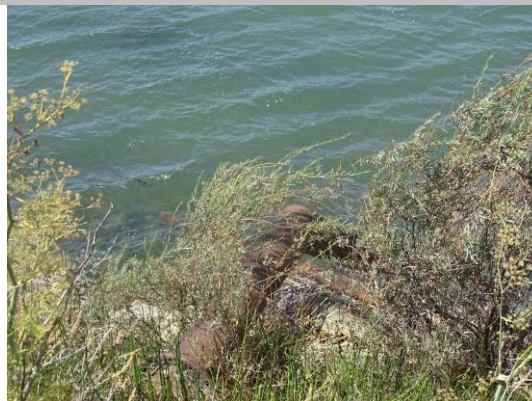
Photo 3 of 3 : UCIP_SP_2020_53343_77900.jpg

WS pipe; thick vegetation made access difficult.

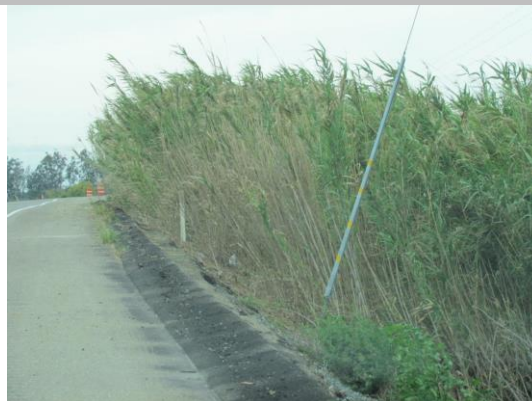
Photo 1 of 1 : SP_2020_RD0341_168_49_20200304_00013.jpg

RD 341 Landside slope from levee mile 6.03-6.10 tall unwanted growth of Arundo present on the levee section.

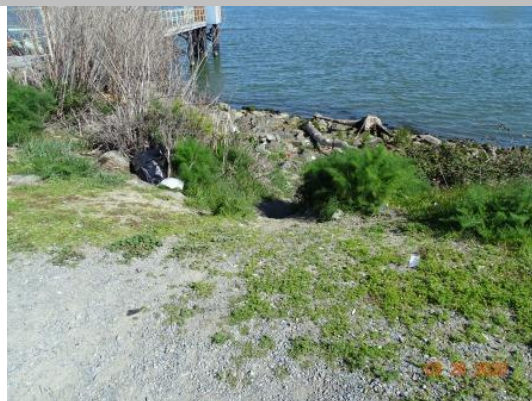
Photo 1 of 1 : SP_2020_RD0341_168_60_20200326_00088.jpg

View of fisherman trail on the waterside slope (Spring 2020).

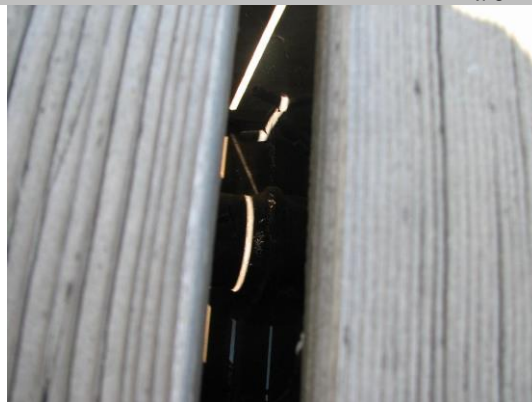
Photo 2 of 3 : UCIP_SP_2020_22263_37961.jpg

Unable to confirm number of pipes.

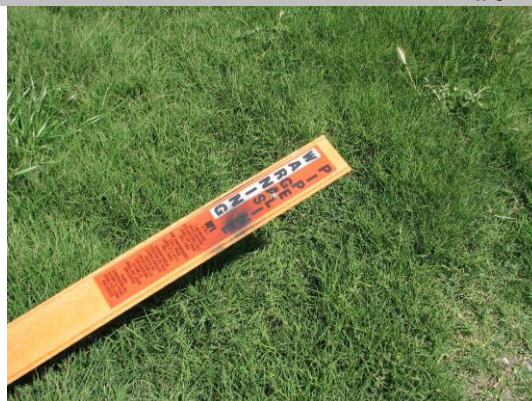
Photo 3 of 3 : UCIP_SP_2020_22263_37960.jpg

Marker damaged on waterward side.

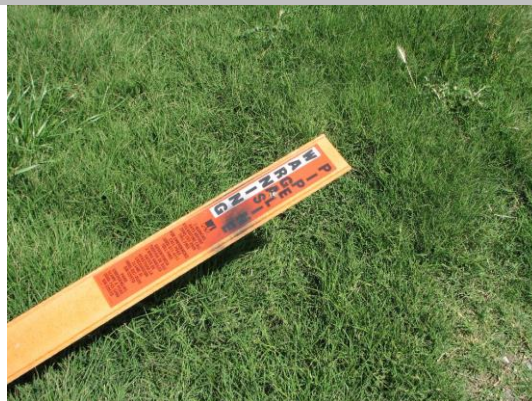
Photo 3 of 3 : UCIP_SP_2020_22264_37963.jpg

Damaged marker located on waterward side.

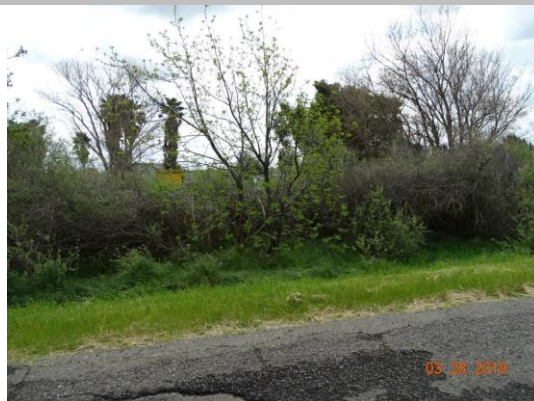
Photo 1 of 1 : SP_2020_RD0341_168_51_20200304_00014.jpg

View looking downslope at landscaping on the landside slope (Spring 2019).

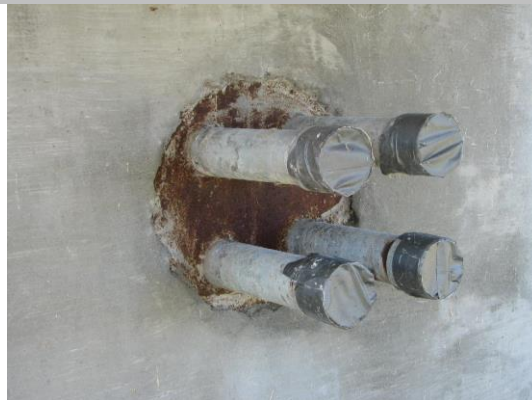
Photo 2 of 3 : UCIP_SP_2020_22303_38061.jpg

Conduits exposed on waterward side.

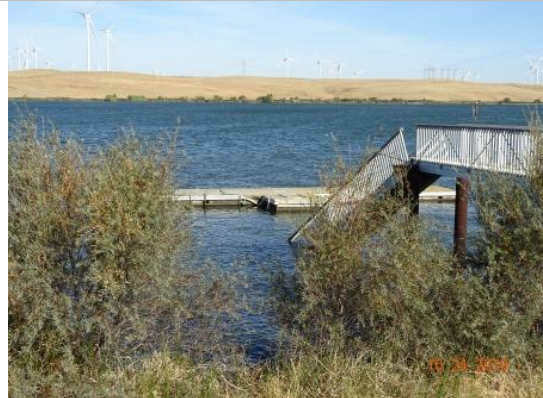
Photo 1 of 1 : SP_2020_RD0341_168_53_20200304_00015.jpg

View of stairs that are not attached to the boat dock (Fall 2019).

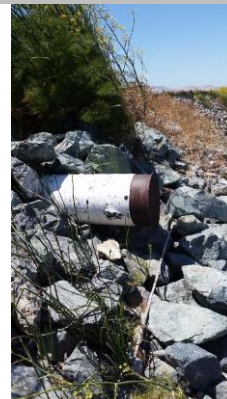
Photo 2 of 3 : UCIP_SP_2020_50082_75942.jpg

New pipe(non-functional) metal plate installed on the WS.

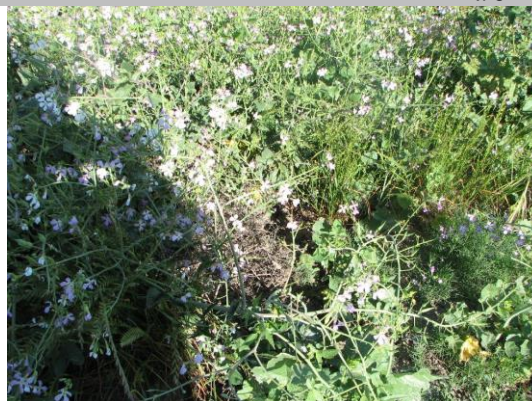
Photo 2 of 3 : UCIP_SP_2020_22324_38095.jpg

Potential subsidence in slope however difficult to determine due to dense vegetation.
